## Structural Insulated Panels: Impact on the Residential Construction Process

Michael A. Mullens, P.E.<sup>1</sup>; and Mohammed Arif<sup>2</sup>

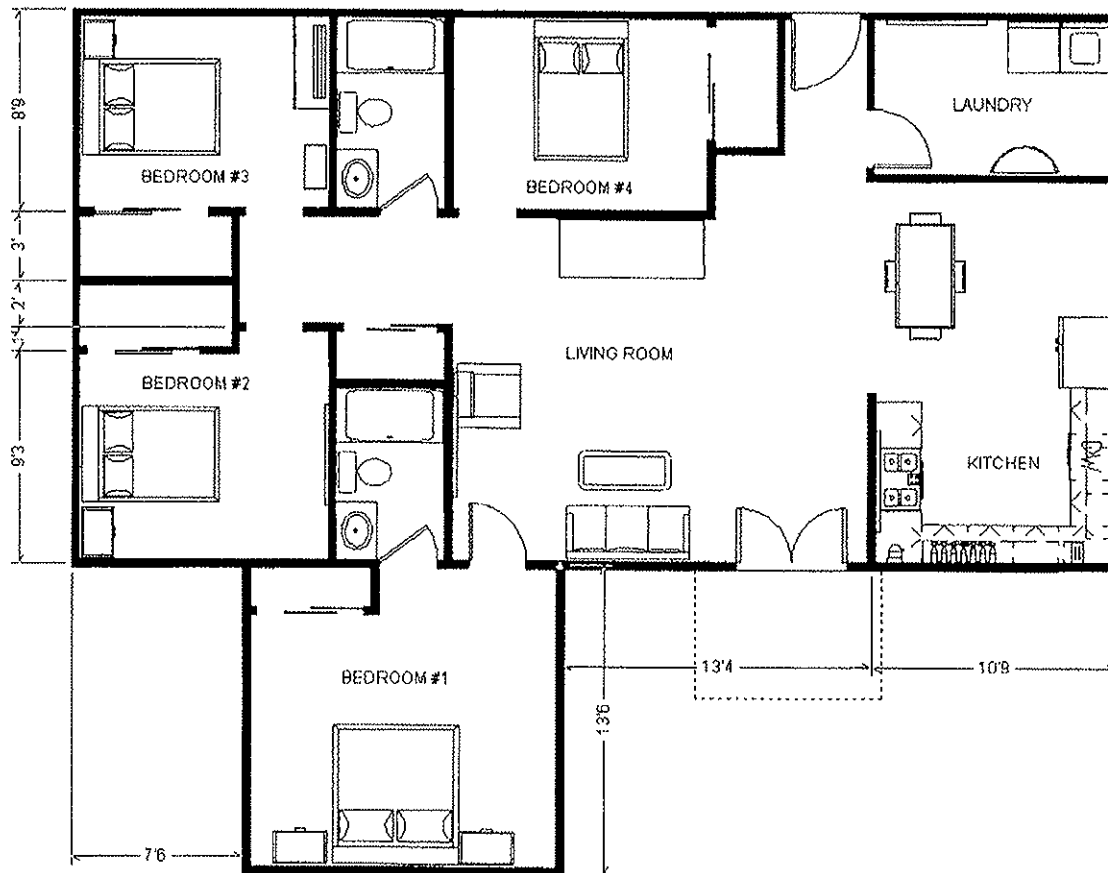
Fig. 2. Floor plan of SIP home
